GREAT STREETS FOR SENIORS UPTOWN STREETSCAPE STUDY

City of New Westminster | Bunt & Associates | UBC School of Community Regional Planning

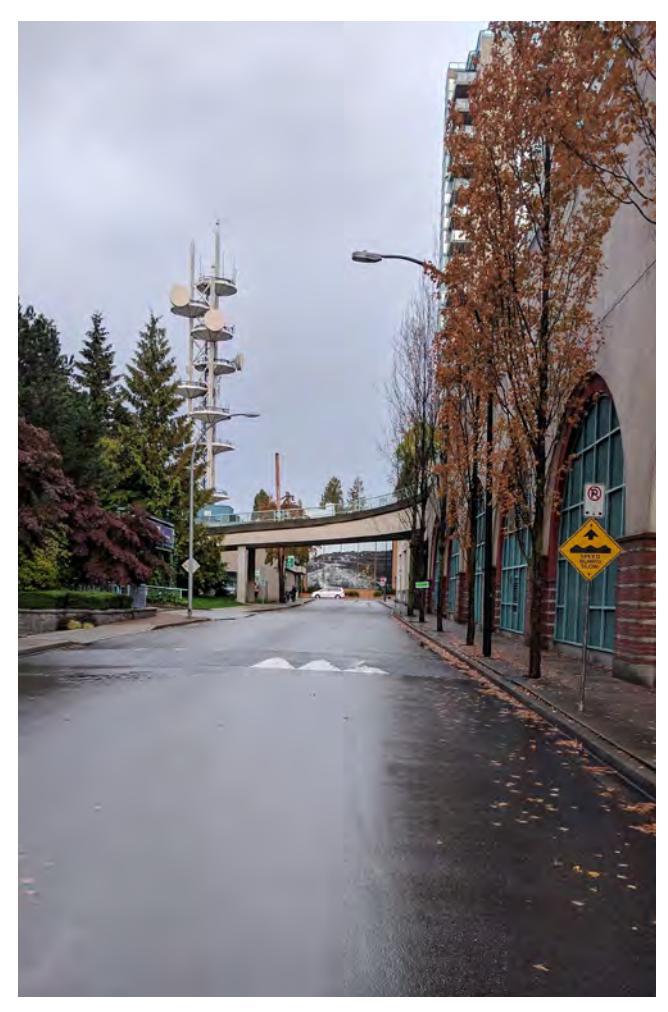
Traffic calming measures along Princess St improve safety for pedestrians and encourage more responsible driving

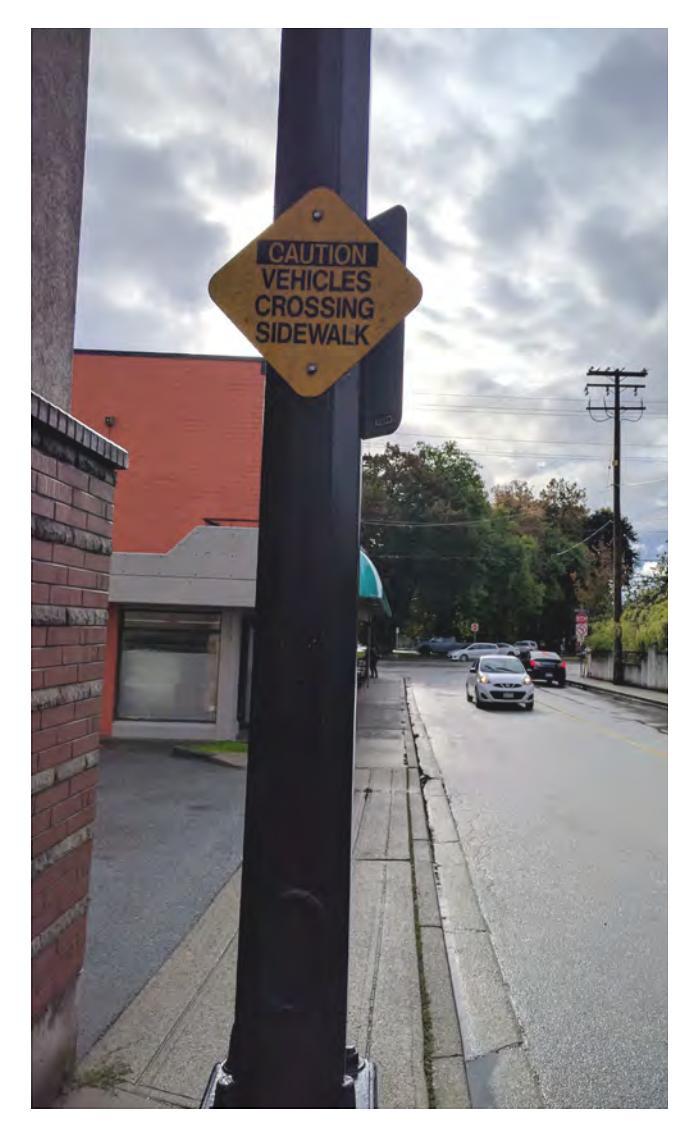
Obstructions on the sidewalk can come in many forms, such as this streetlight on Princess Street

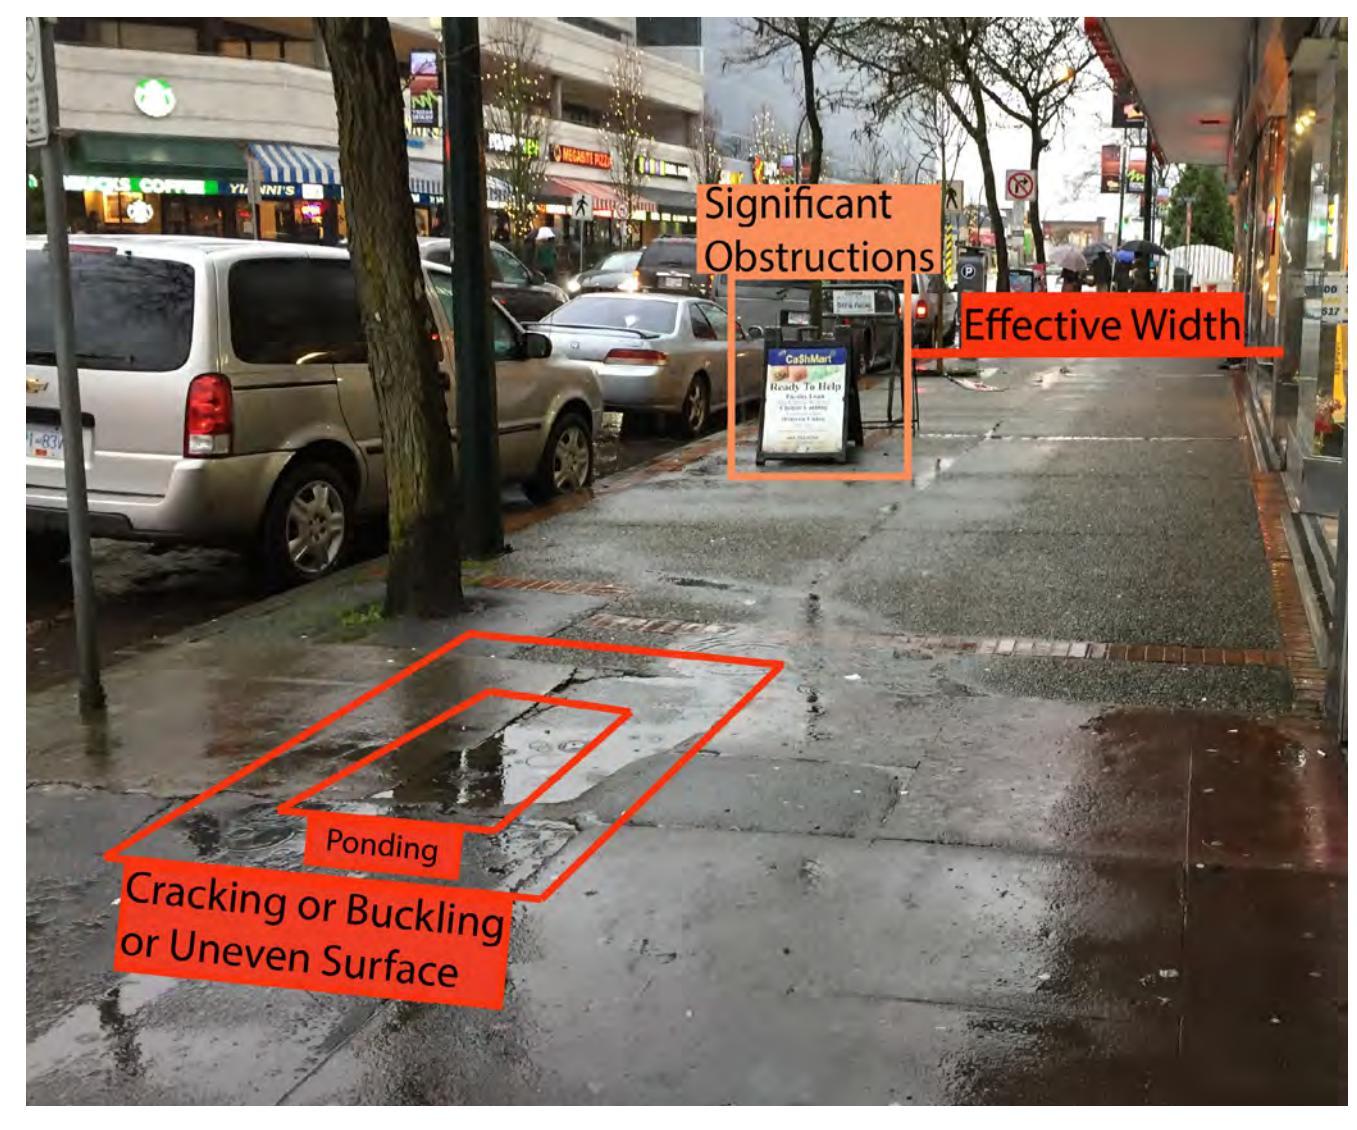
The adjacent image illustrates the three problem types in red.

Problems that the team focused on in this section (Location: 6th St)

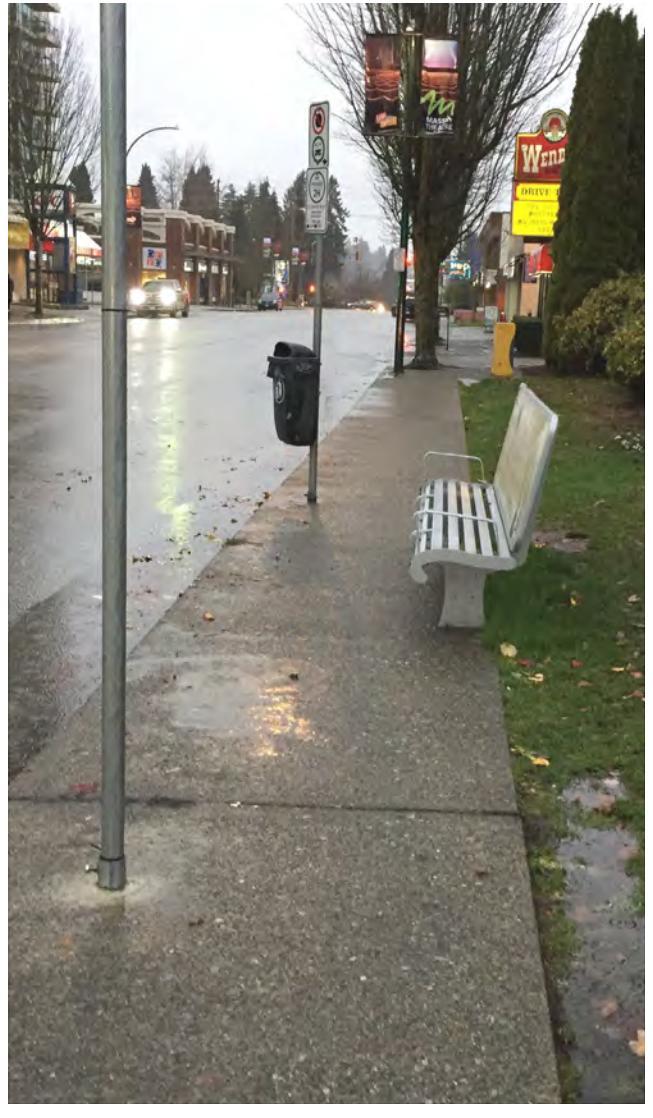
One of the narrowest effective widths in the study site was recorded on 6th St between Hamilton St and 8th Ave

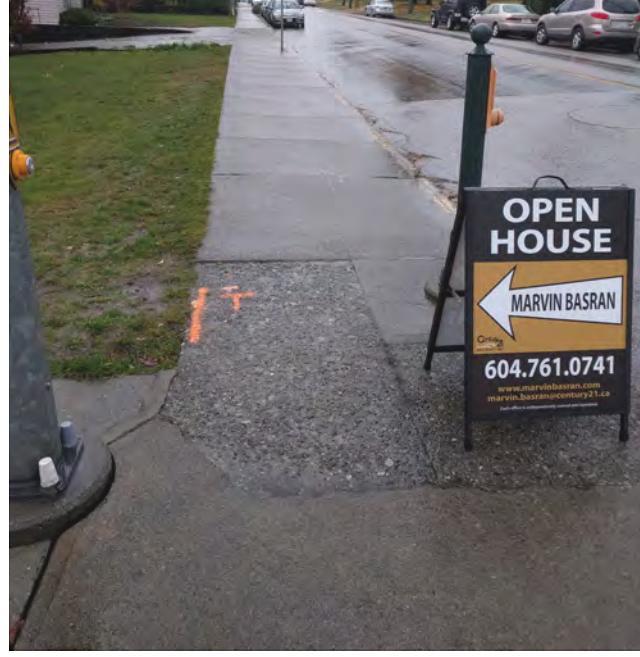
Sandwich board that creates a significant obstruction and imits the effective width of the sidewalk (Location: 6th Ave & 10th St)

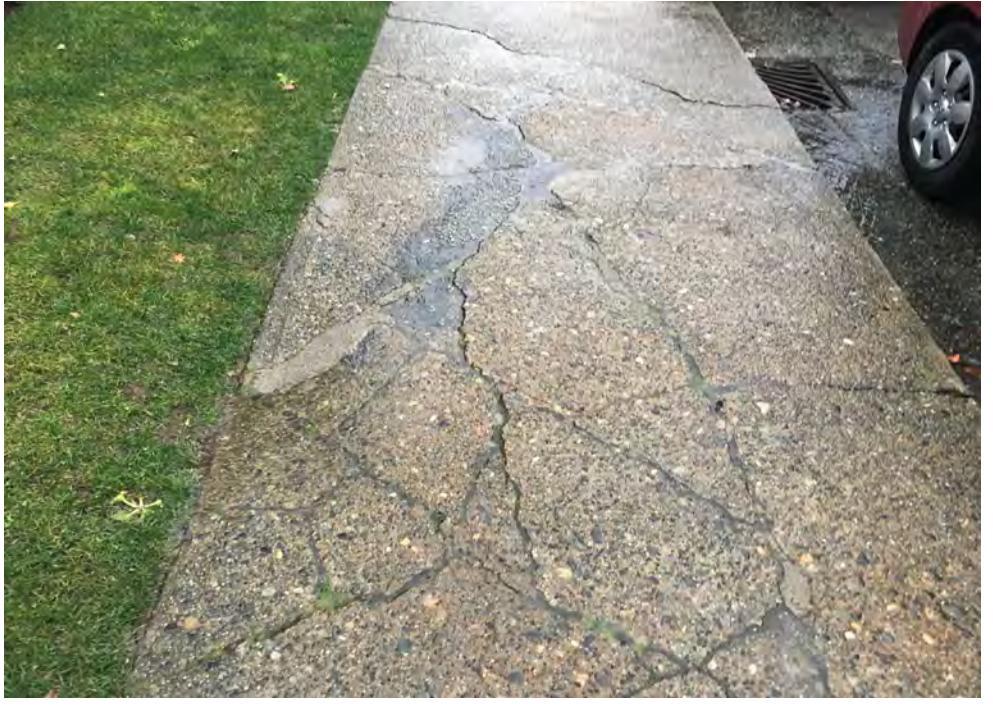
Extended damage of the sidewalk, leading to uneven surface in a high senior pedestrian traffic location right outside the Century House on 8th St

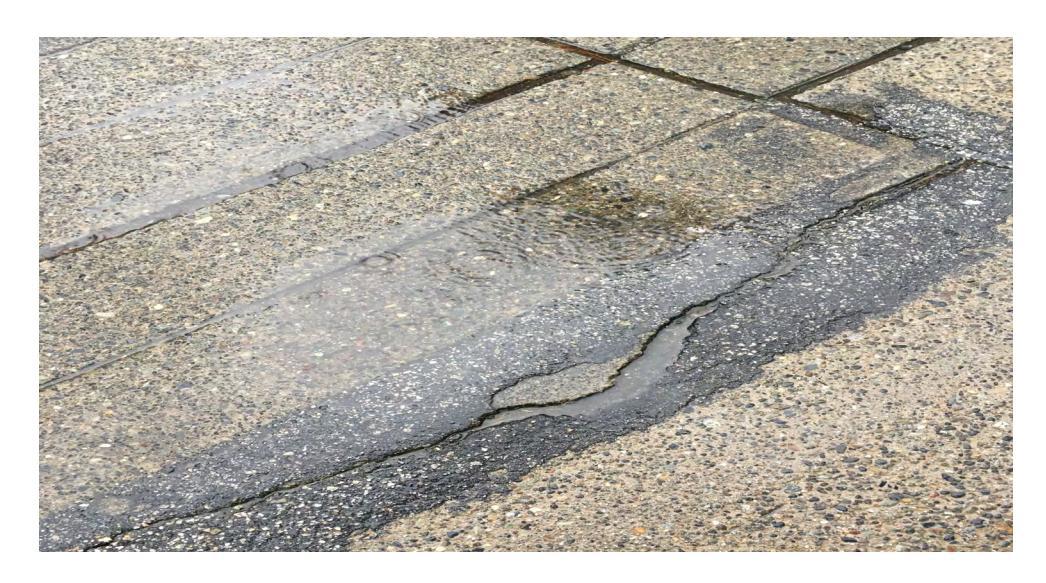
Instance of cracking along Hamilton St

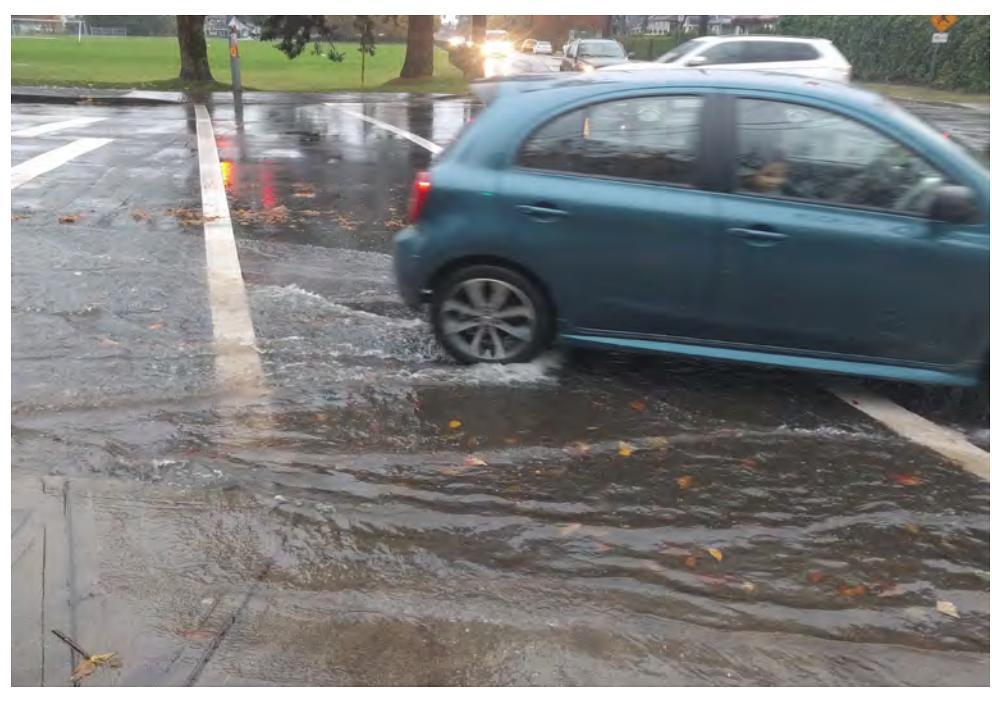
Instance of heavy ponding on the intersection of 8th St & 8th Ave

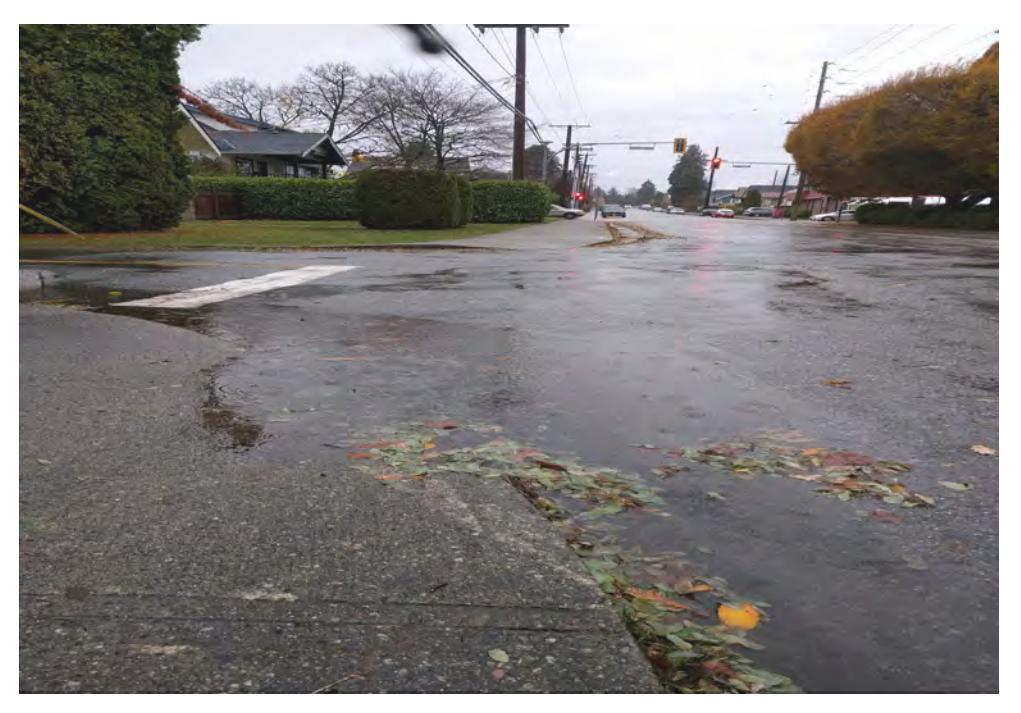
Instance of ponding on the intersection of 10th St & Kingston St

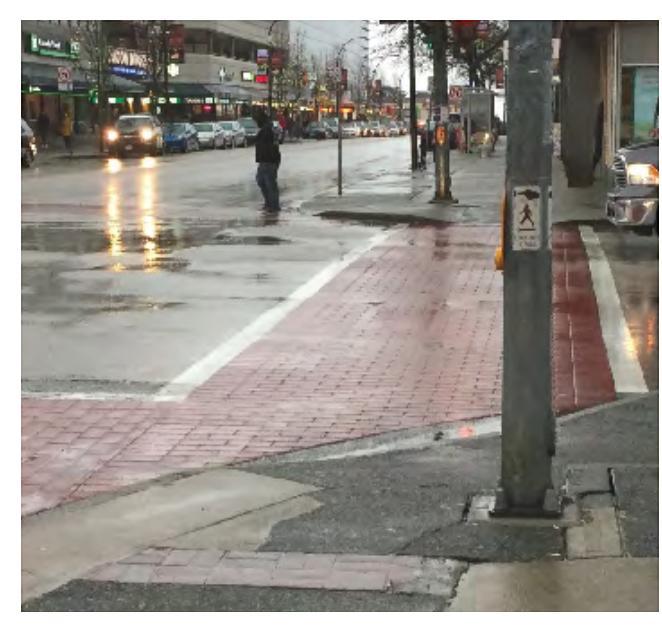
The intersection has crosswalks with a different colour and texture, which are more visible to drivers. The curb letdown at the closest corner (the north-west corner) is suboptimal as it enters into the intersection

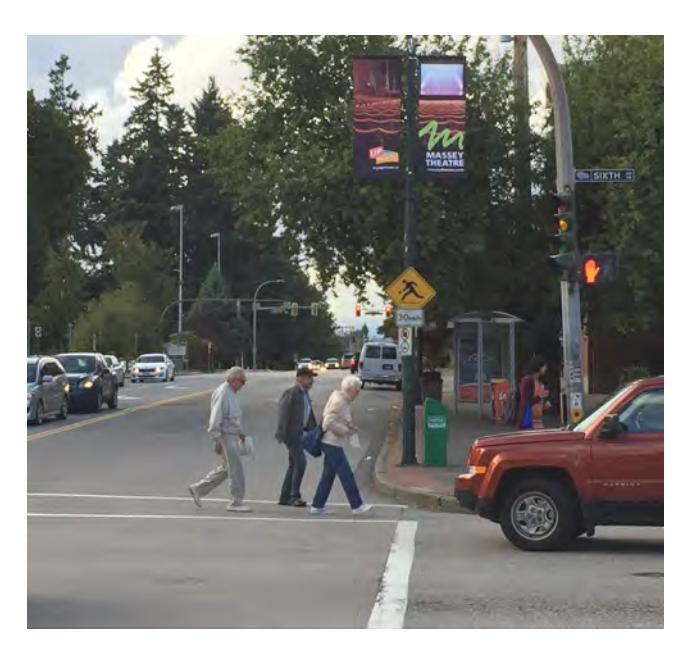
Three senior pedestrians are unable to cross 8th St on the north side in time for the light cycle. The light has turned yellow. None of them are using walking aids

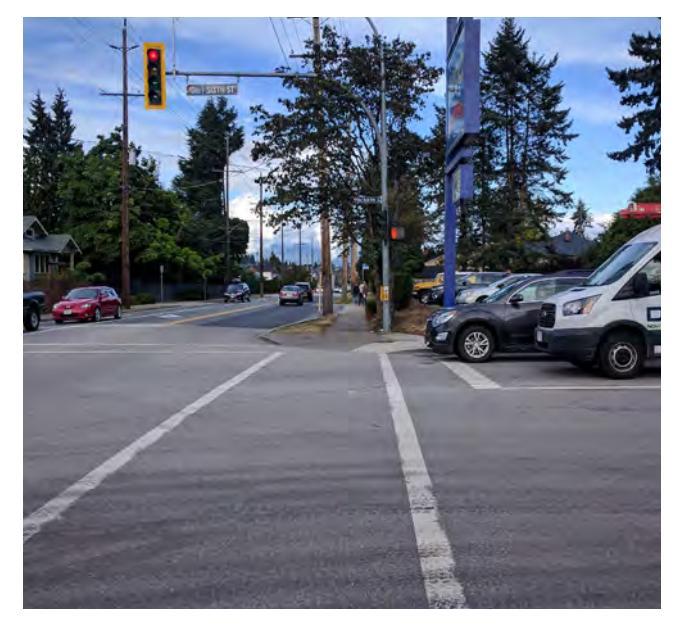
The curb letdowns on the east side of the intersection are not ideal (south-east pictured here). The crosswalks are worn

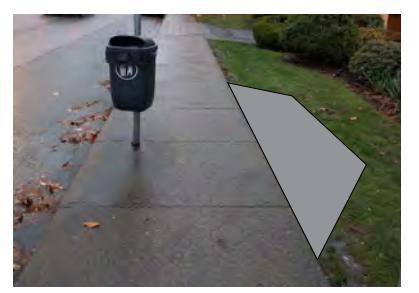
As a quick-win and where is feasible, the City could extend the sidewalk in order to accommodate an effective width of 2m
